Carbon Monoxide Poisoning at a Surface Coal Mine ...

A Case Study

Anatomy of the CO Poisoning

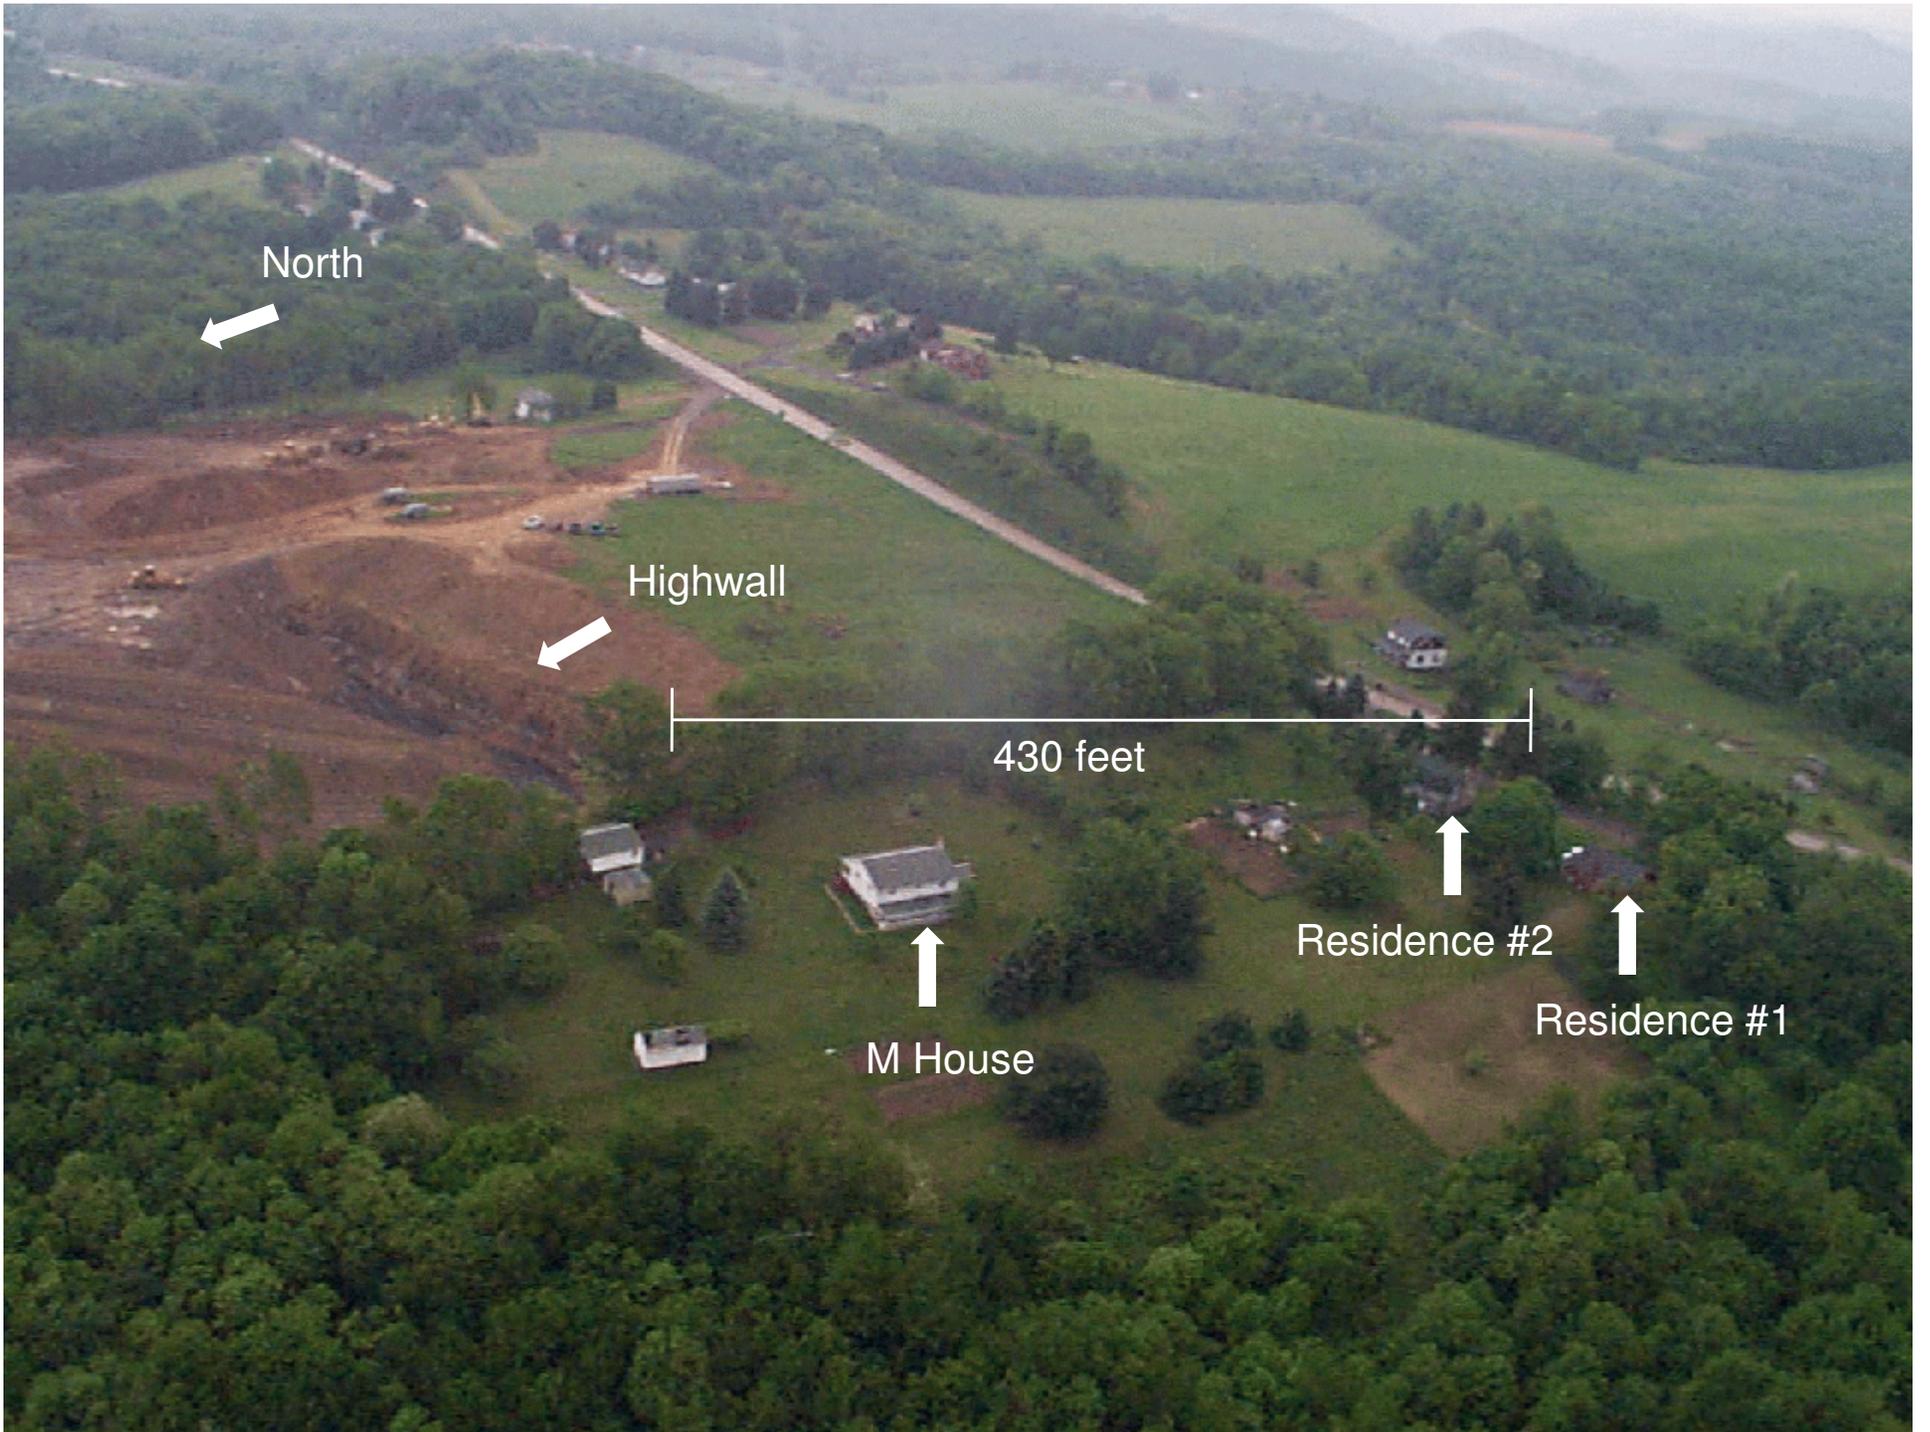
North

Highwall

430 feet

M House

Residence #2

Residence #1

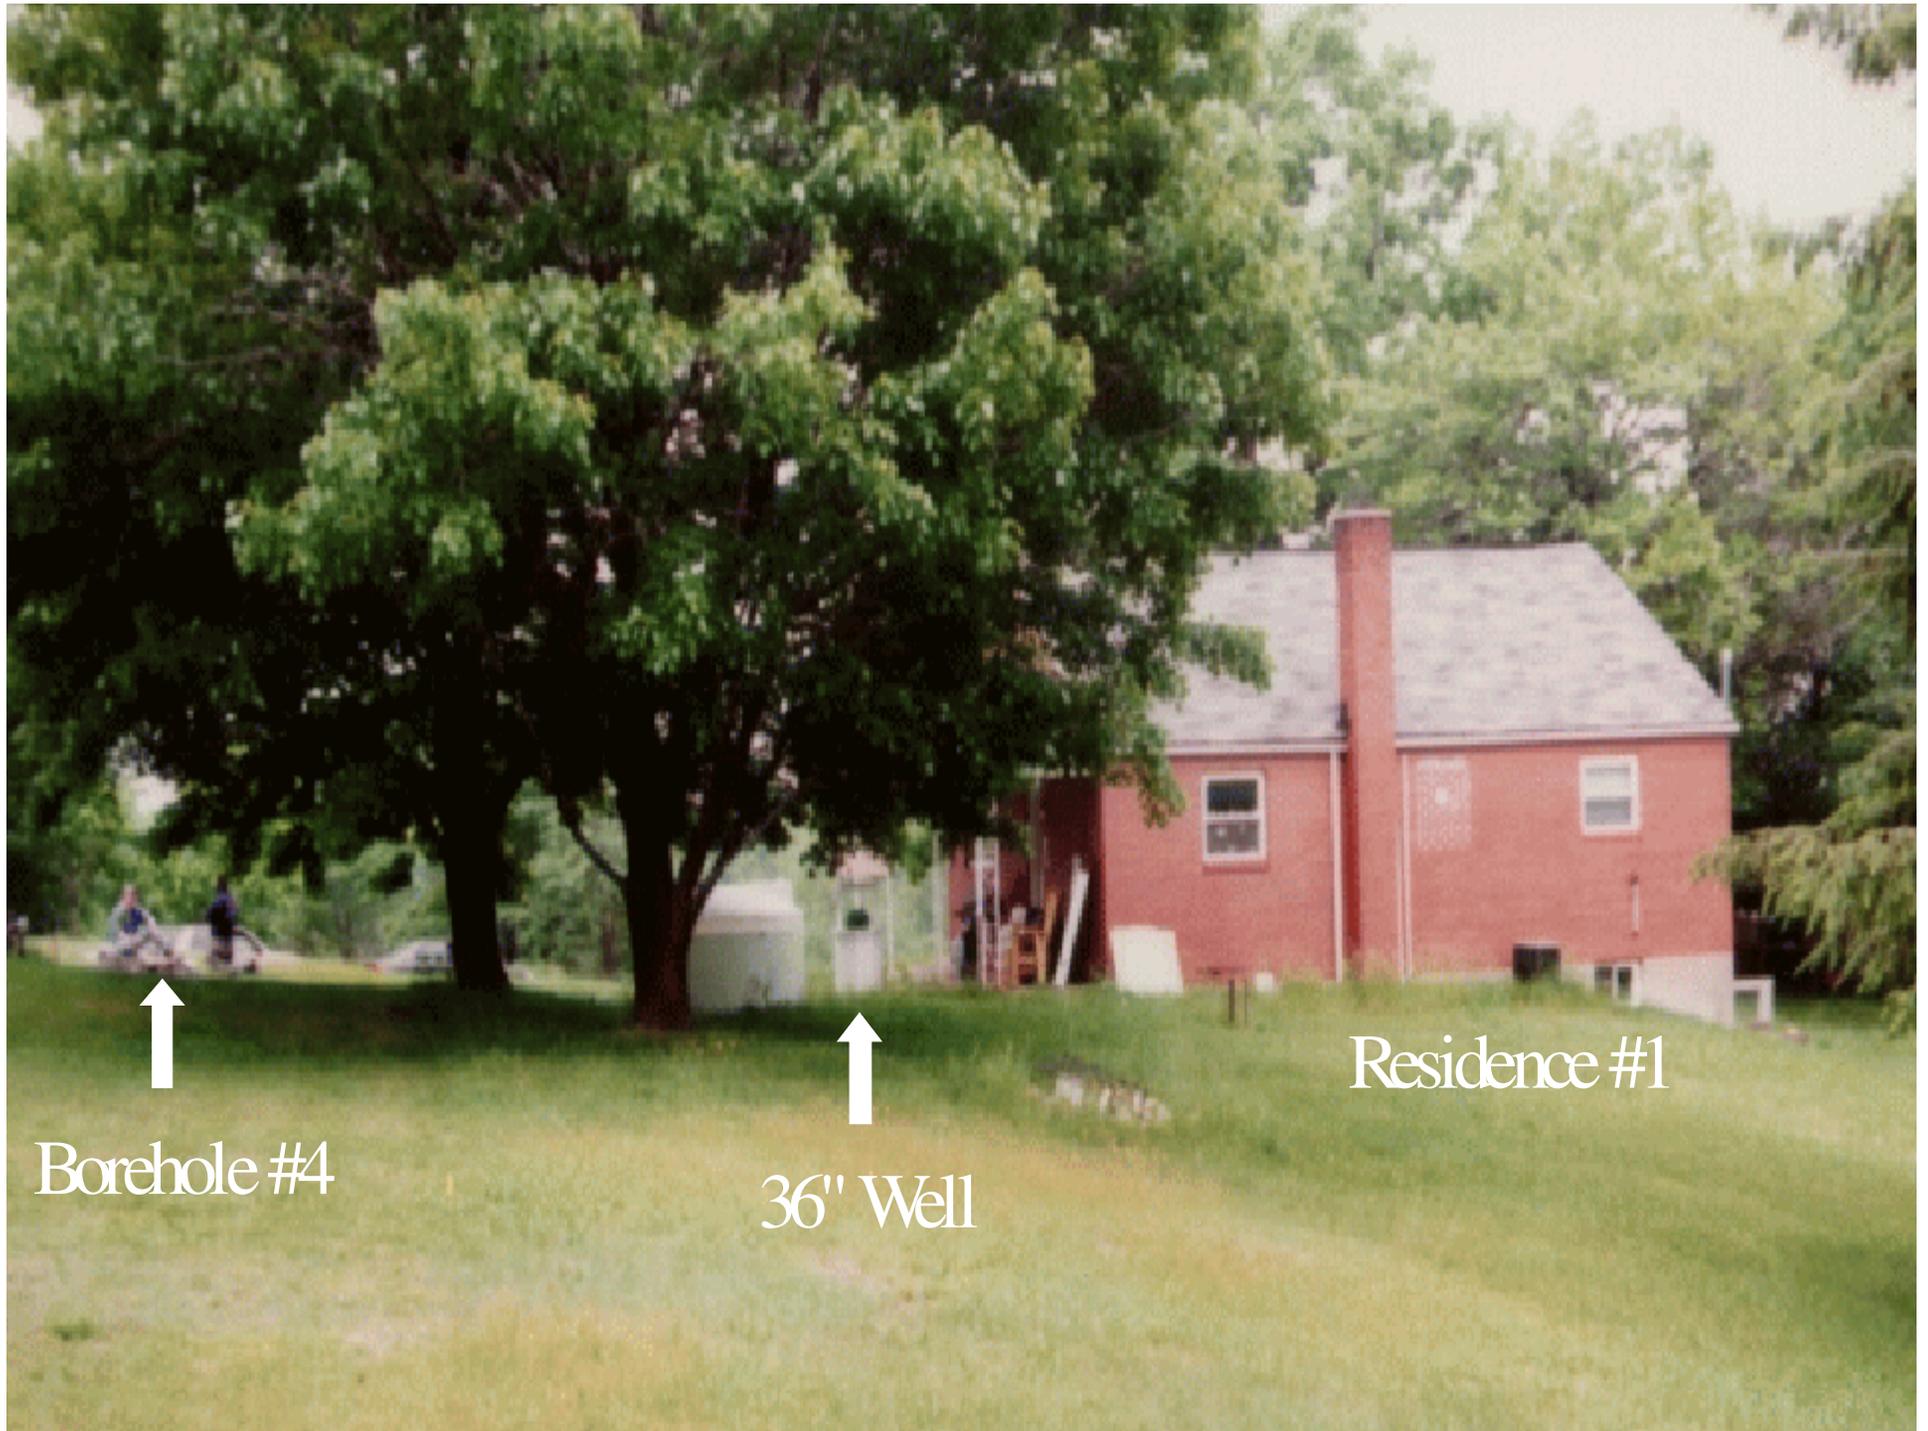
Borehole #4

36" Well

Residence #1

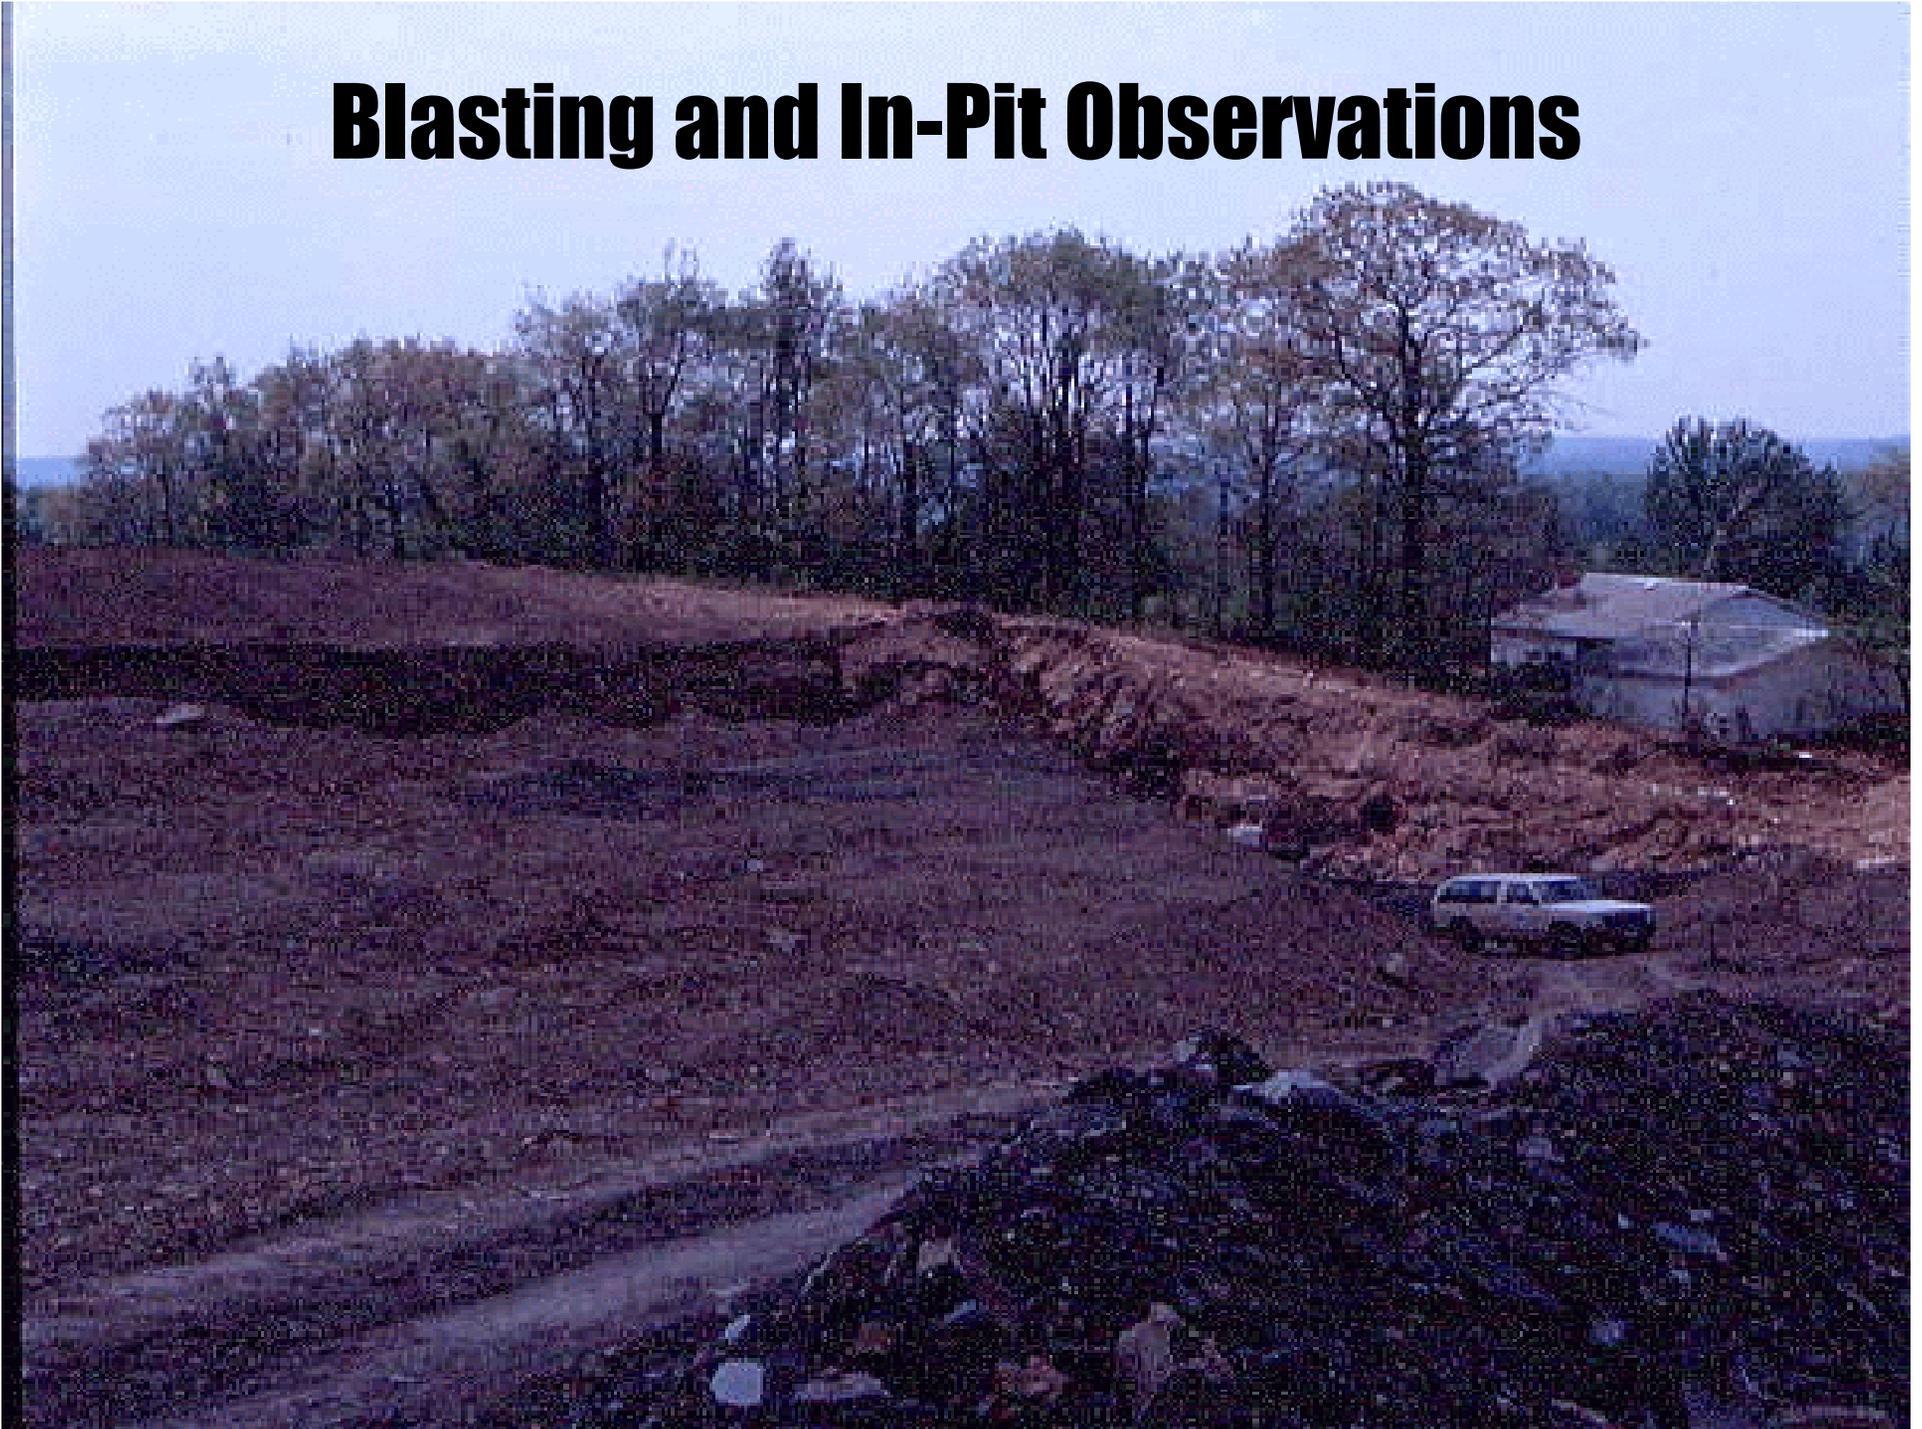
Blasting and In-Pit Observations

ANFO (3.4% FO)

ANFO (5.5% FO)

ANFO (8.0% FO)

Blasting Fumes

1. Poor product formulation
2. Inadequate priming
3. Insufficient water resistance
4. Lack of confinement
5. Reactivity of the explosive with the rock
6. Incomplete product reaction.

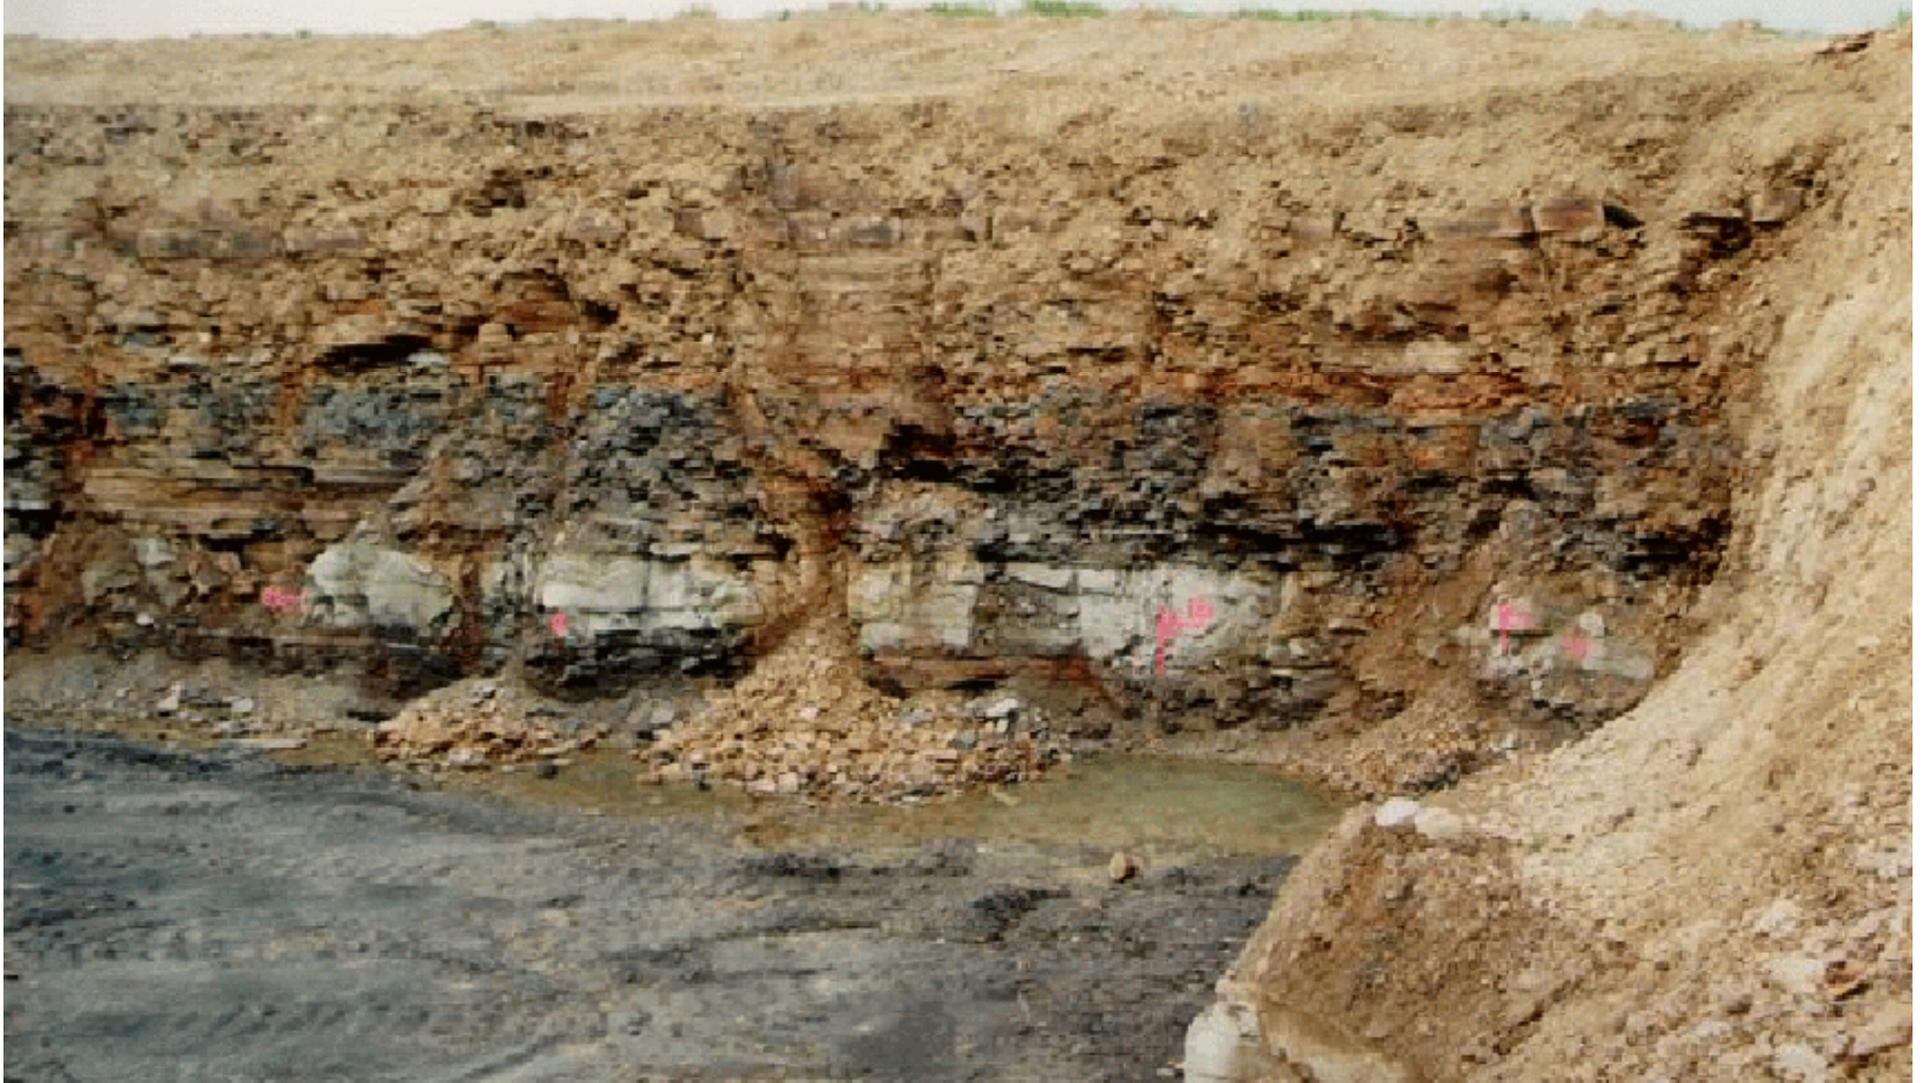
30' overburden, 6' sandstone 3' above coal

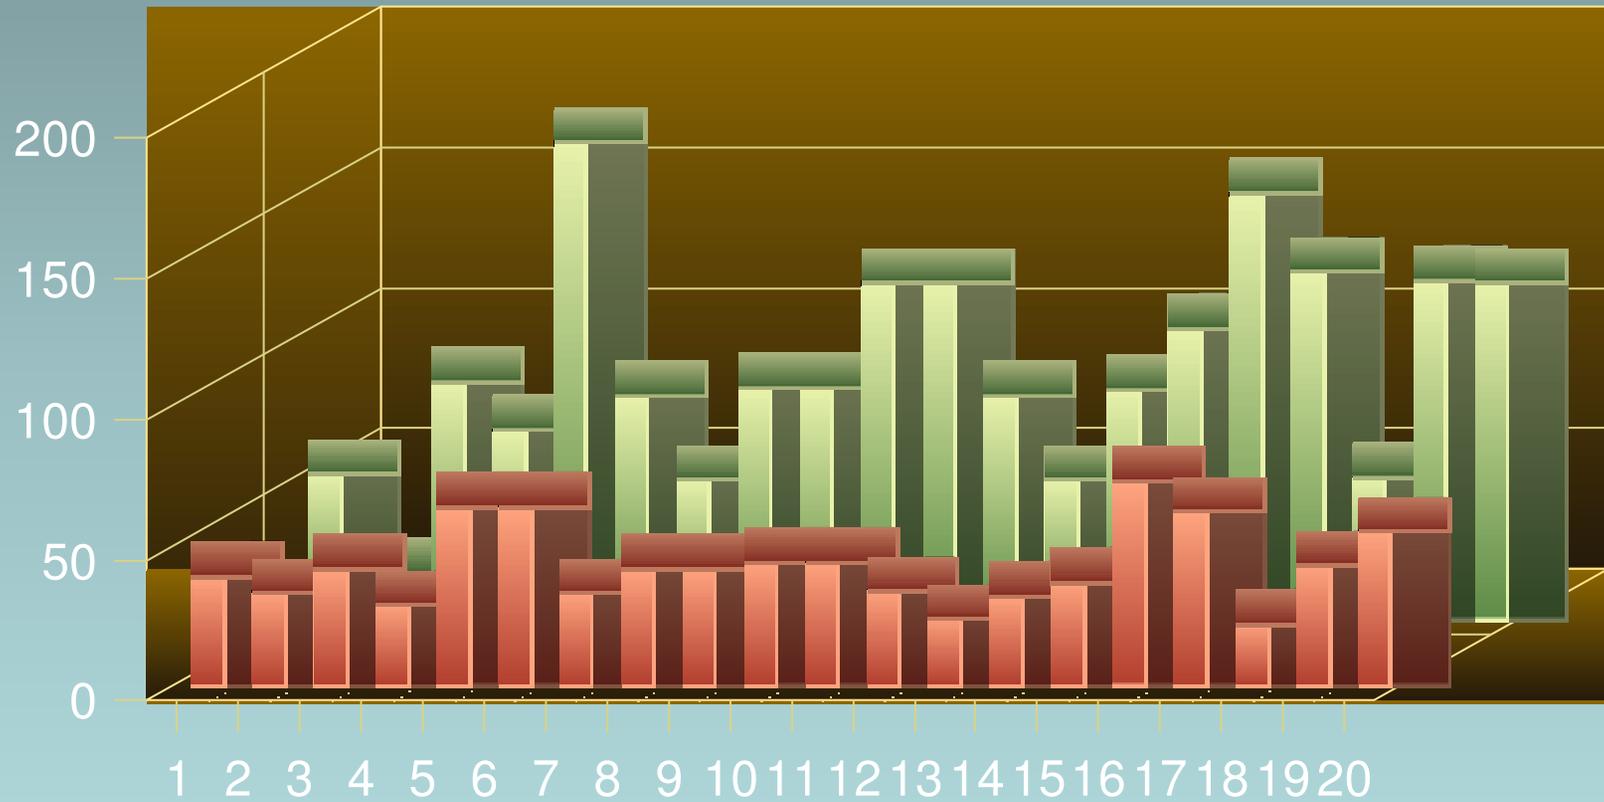
Blasting Data

Charge per Hole (lbs)

Powder Factor (lb/yd³ x 100)

- 16 to 89 holes
- 6 1/4 inches in diameter
- 16' X 16' pattern
- Powder column 1 1/2 to 15 feet
- ANFO with 1 lb booster
- Non-electric initiation
- Stemming 13 to 24 feet

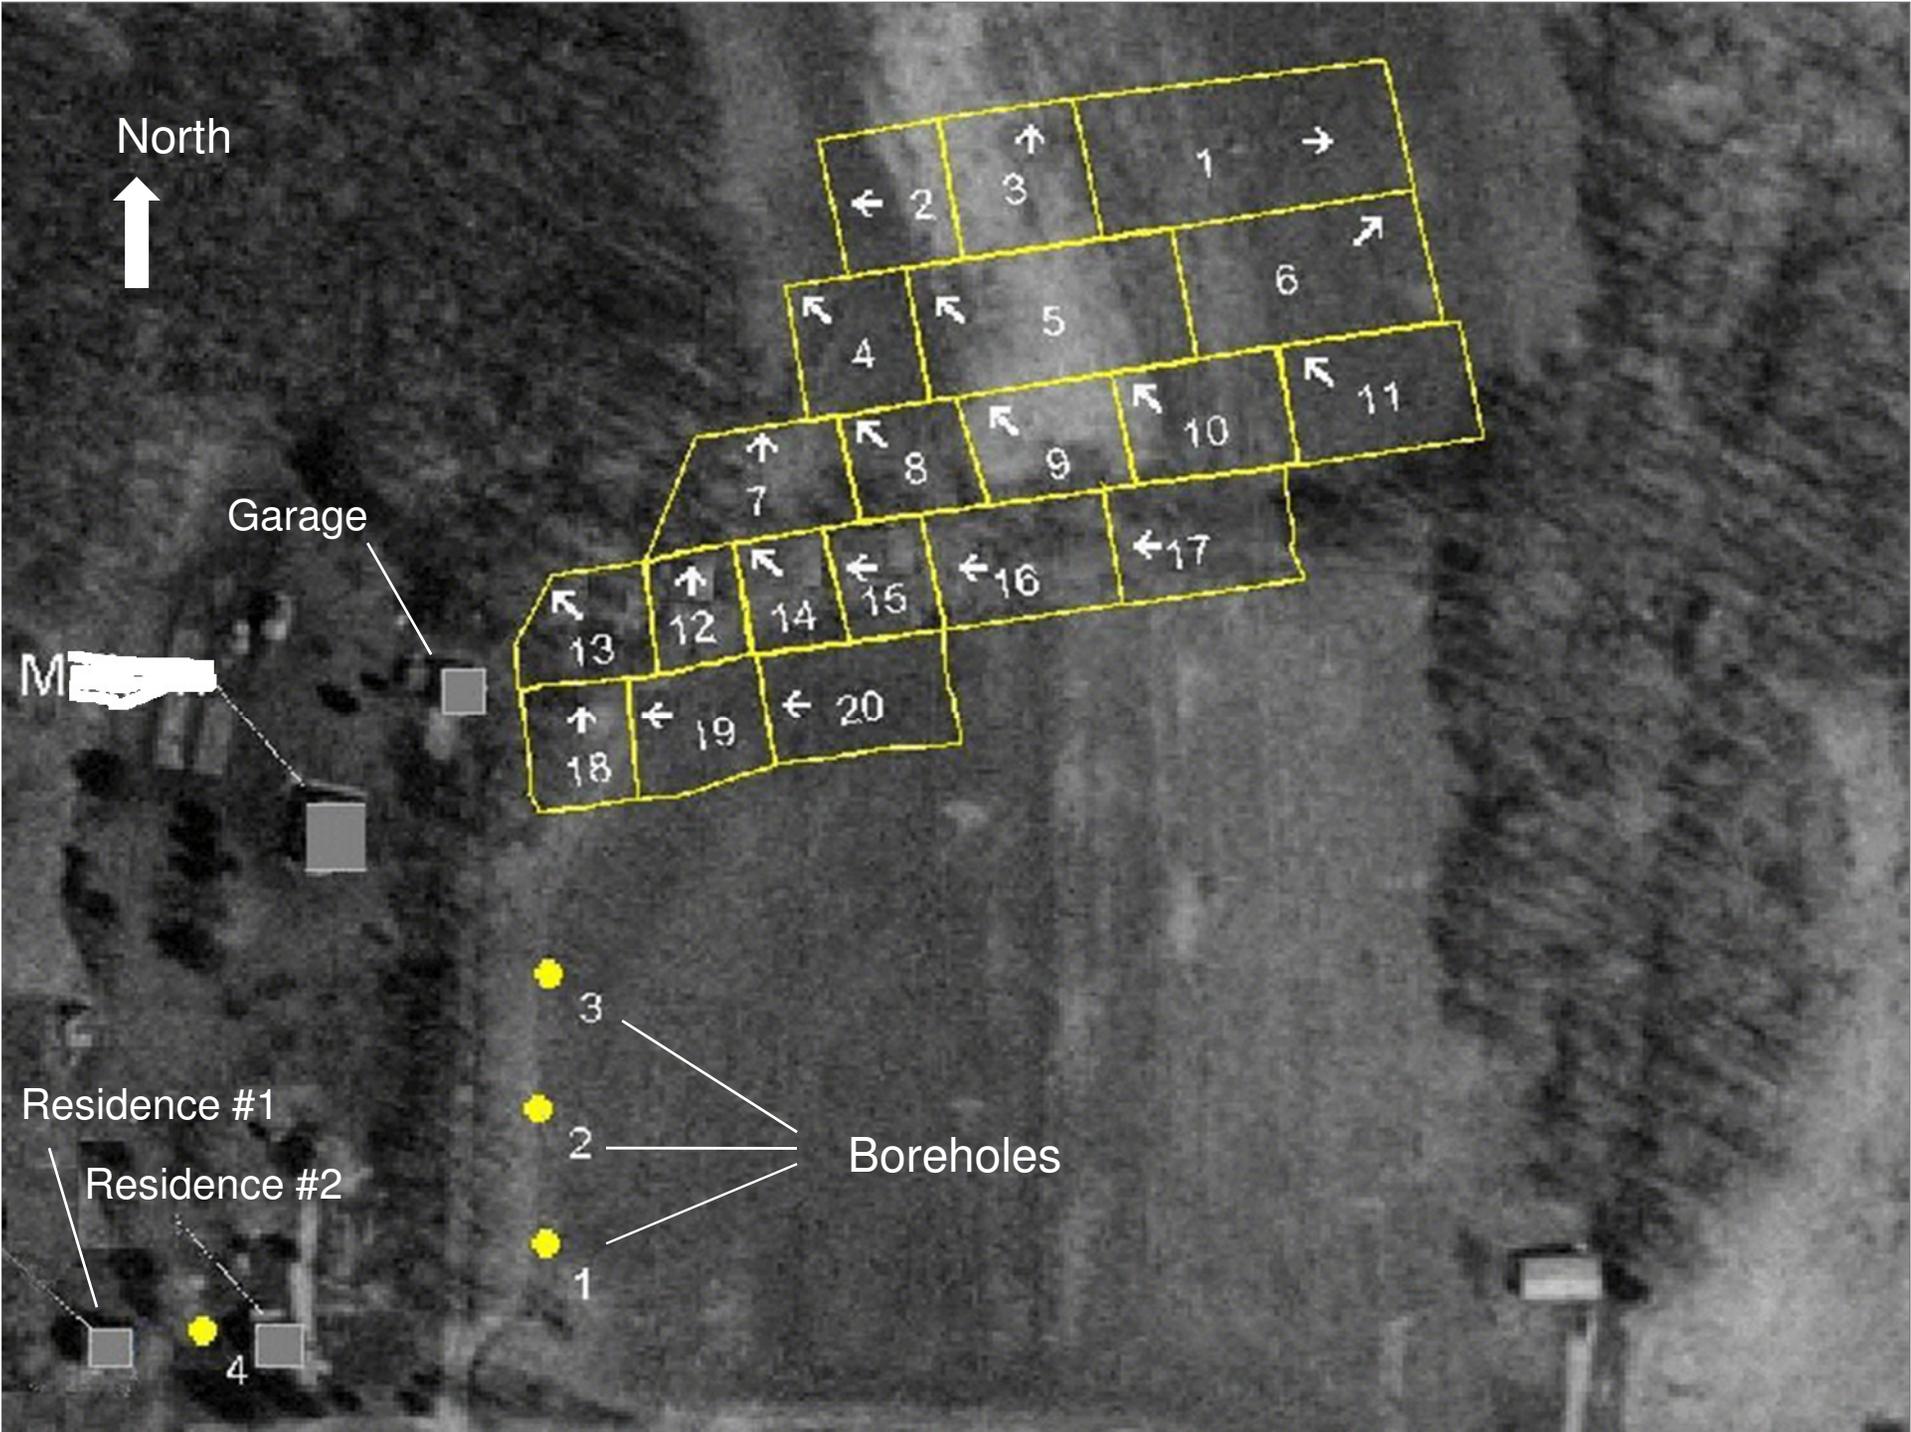
North

Garage

M

Residence #1

Residence #2

Boreholes

- May 31, 2000
- Four holes
- Hole number 2 - 28 - 33 feet sandstone w/ 1' crevice

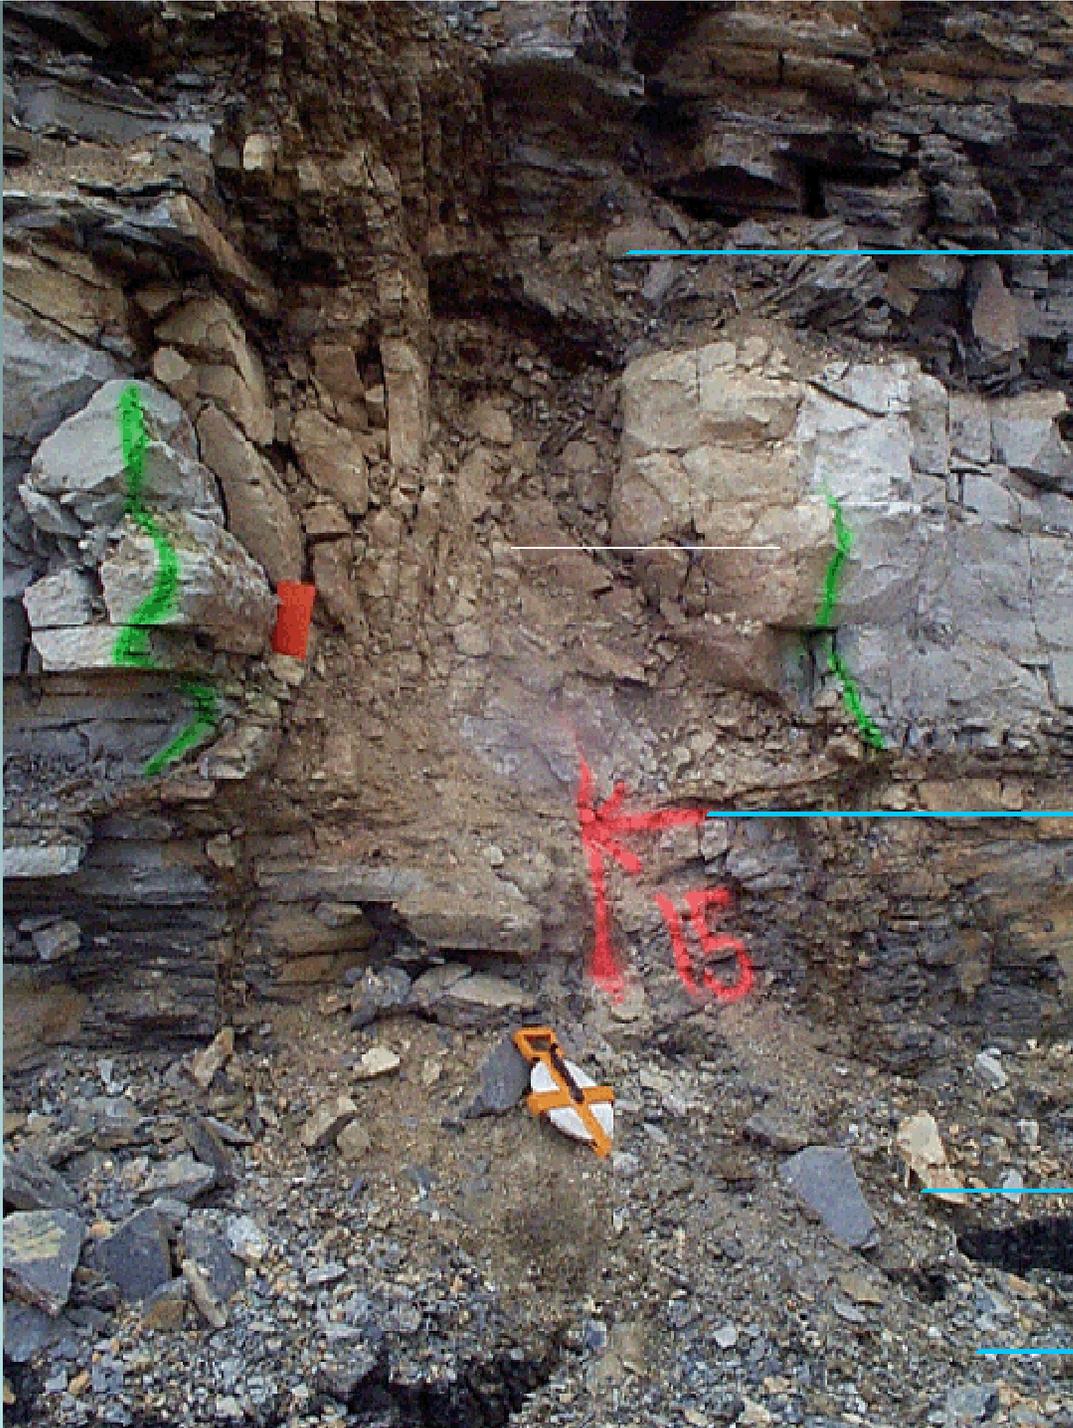
↑
Grey SH 1

Grey SS

Grey SH 2

U.F. Coal
↓

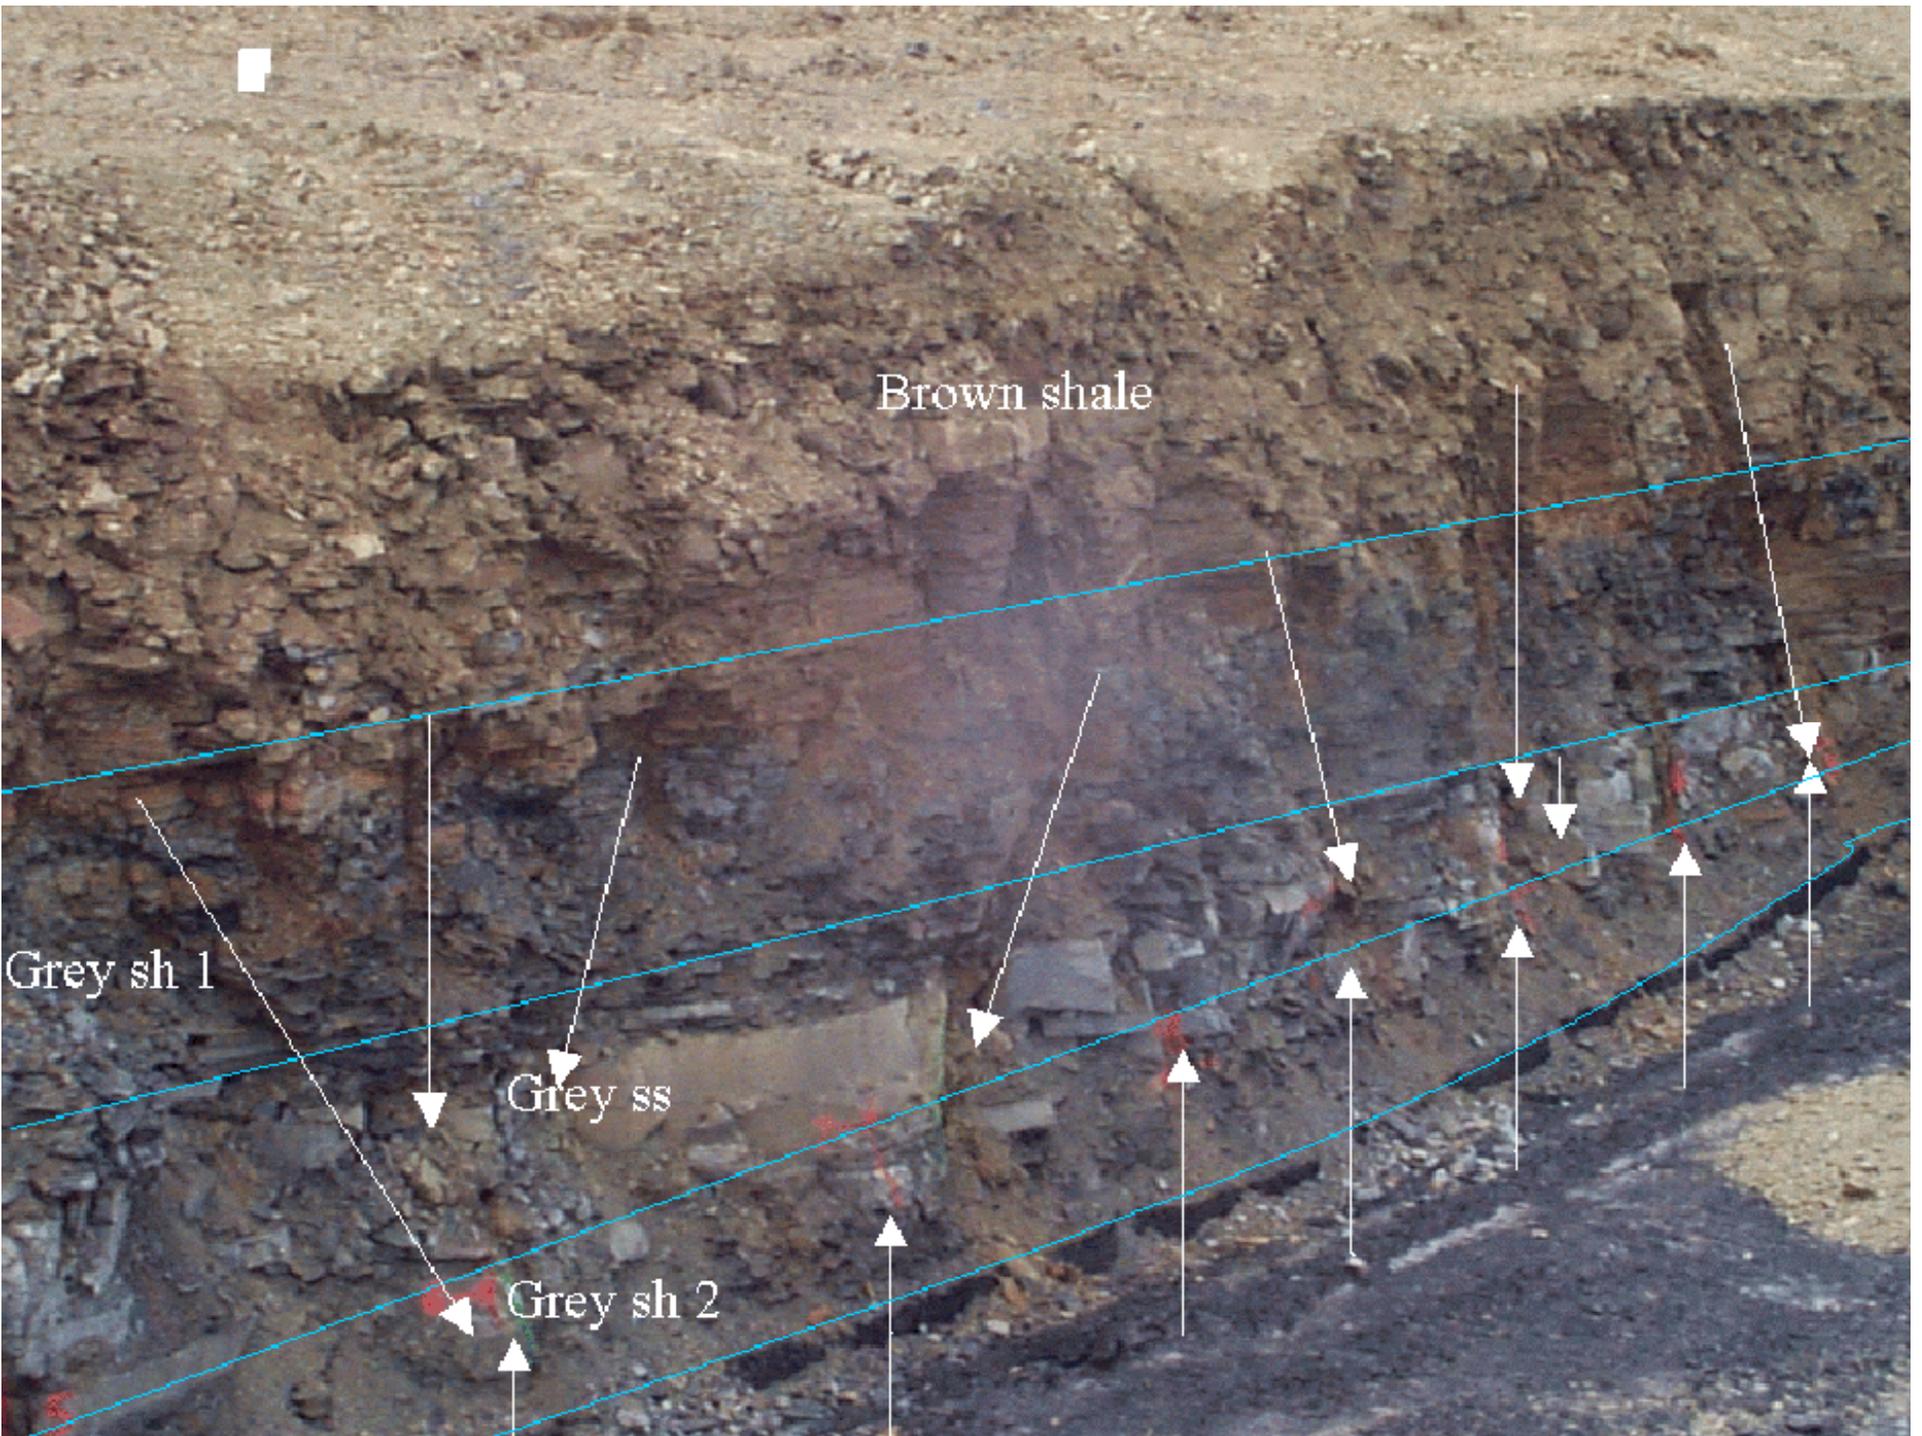
Brown shale

Grey sh 1

Grey ss

Grey sh 2

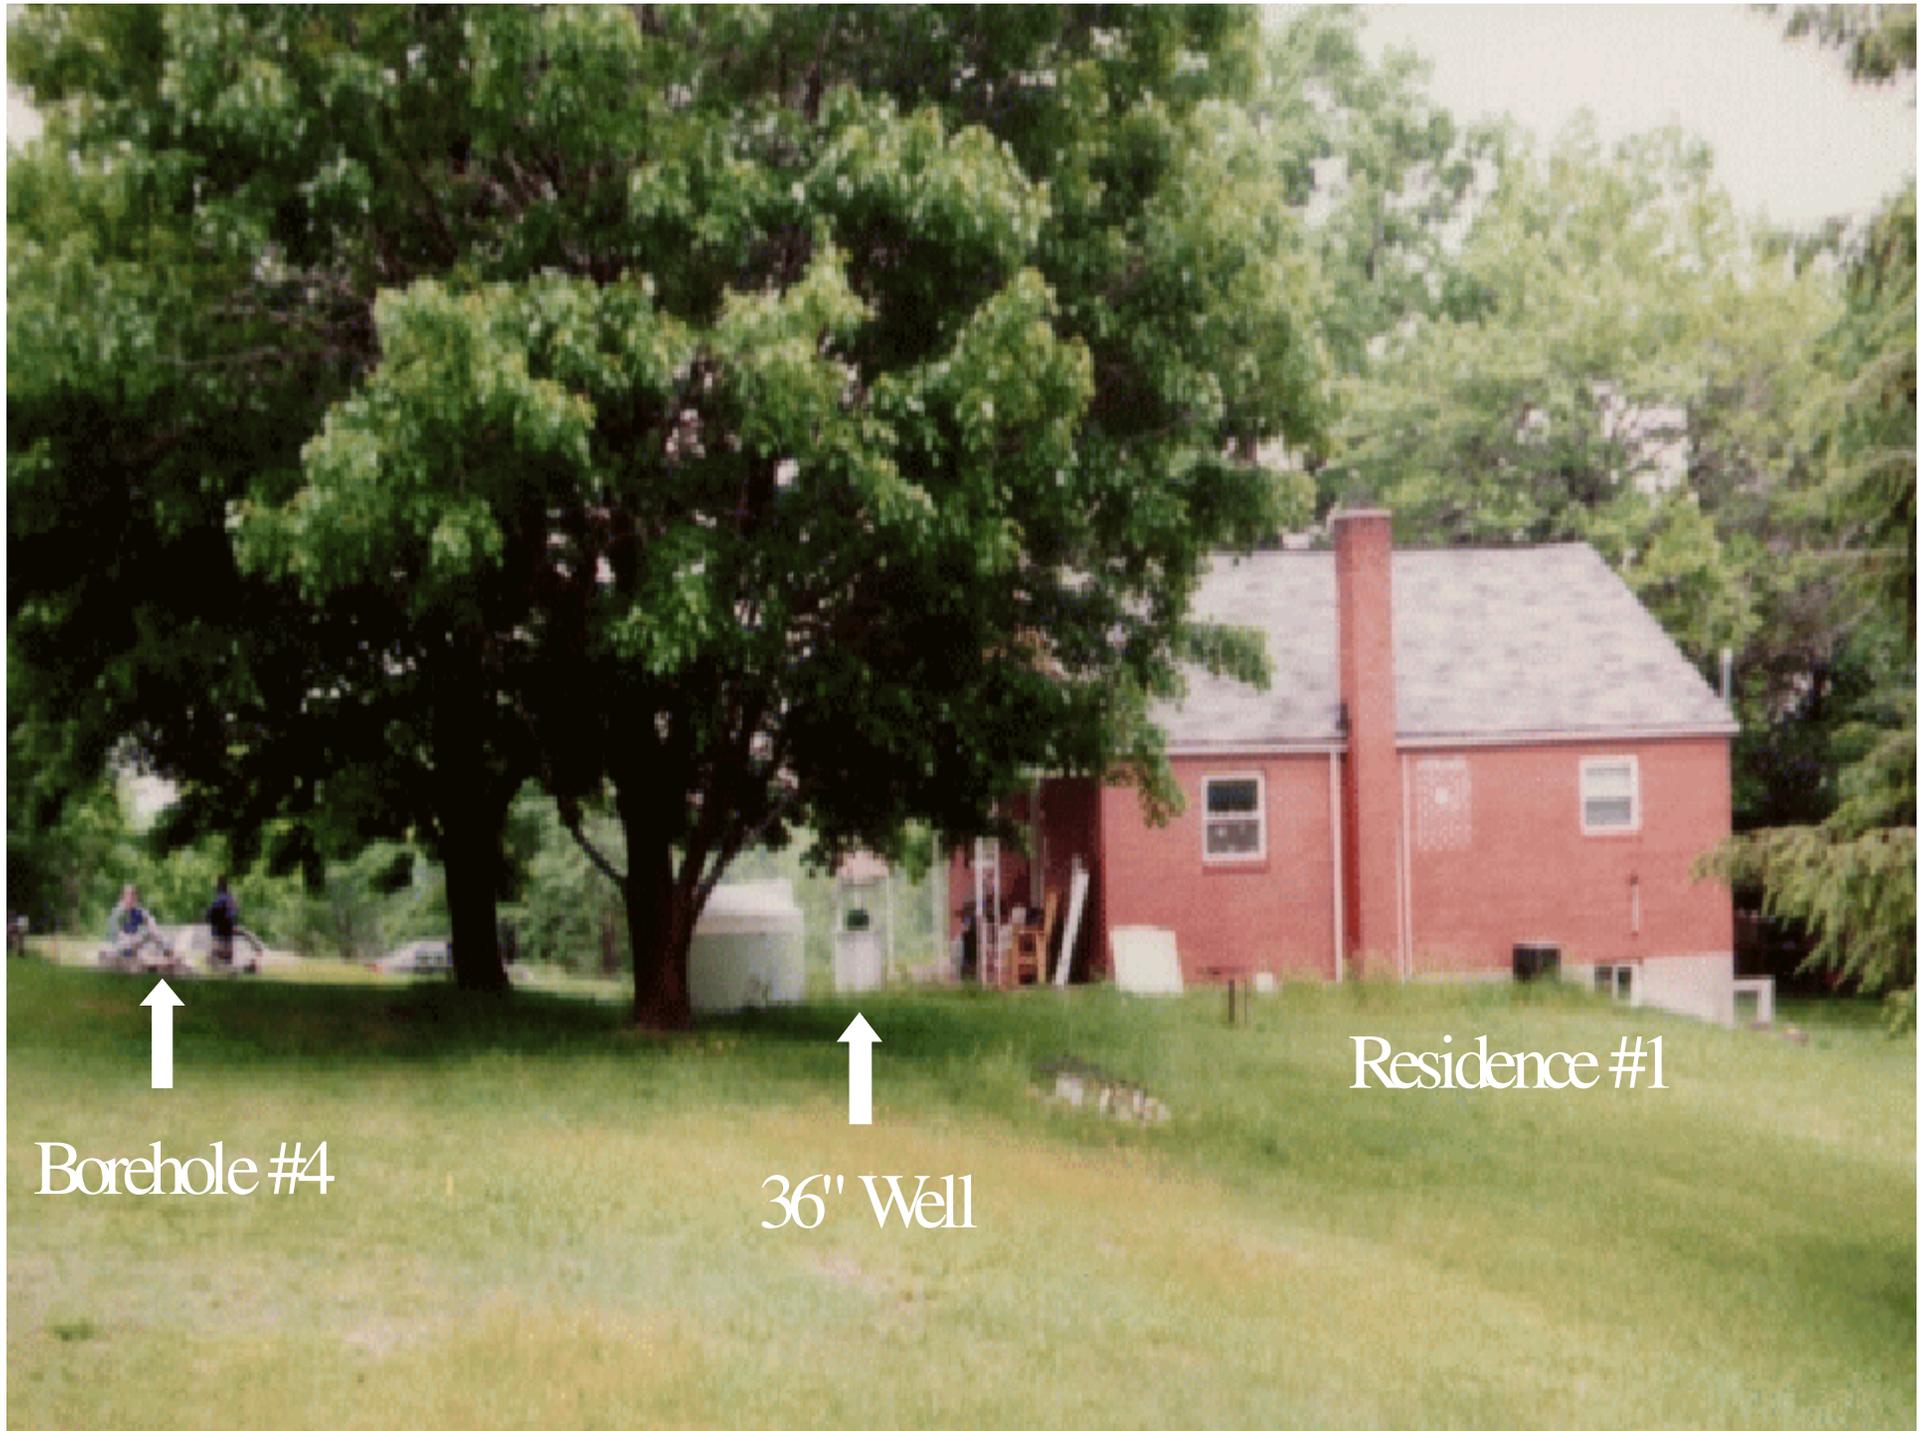
Borehole #4

36" Well

Residence #1

- Flyrock control - Primary focus of the blaster
- Inadvertently contained gases in the ground
- Blast holes were aligned with the fracture system
- Site geology provided a “pipeline and reservoir”
- A large diameter well collected the gases
- The french drain was openly connected to the floor drains
- ALL of these combined to cause the poisoning
